I. Baron, V. Cilek, O. Krejci, R. Melichar, F. Hubatka. Structure and dynamics of deep-seated slope failures in the Magura Flysch Nappe, outer Western Carpathians (Czech Republic). *Natural Hazards and Earth System Sciences*, 2004, 4 (4), pp.549-562. hal-00299177

# Structure and dynamics of deep-seated slope failures in the Magura Flysch Nappe, outer Western Carpathians (Czech Republic)

I. Baron<sup>1,2</sup>, V. Cilek<sup>3</sup>, O. Krejci<sup>1</sup>, R. Melichar<sup>2</sup>, and F. Hubatka<sup>4</sup>

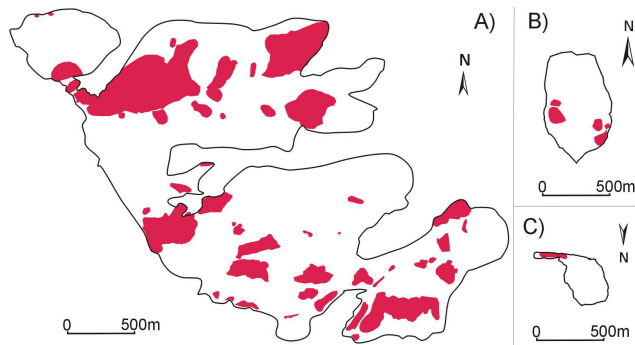
**Fig. 17.** Distribution of slope-movement activity since 1997: (A) Vaculov-Sedlo, (B) Kopce and (C) Kobylska slope failures.

This extreme July rainfall event, the largest in the 20<sup>th</sup> century for the Czech Republic (Pavlik and Sandev, 1997), had only a limited and isolated effect on the triggering of slope movements within the studied case sites (Fig. 17). The main indicators of activity were tree tilting, building damage, freshness of slope-failure features, and dilatometric measurements.

Although the distribution of the activity was rather isolated (Fig. 17A), several types of movement occurred in the Vaculov-Sedlo slope failure area, such as deep-seated block-type rotational and translational slides, and shallow translational and planar slides on bedding planes or bulge and pressure folds. The main damage was observed on shallow, non-block parts of active failures. In total, at least 0.12 km<sup>2</sup> of 100-yr-old forest was affected by mass movements, as well

Within the Kobylska slope failure (Fig. 17B), the most active area since 1997 has been a shallow secondary landslide within the accumulation zone of the diminishing block slope failure at the front of the SE side of the main block. In addition, block slides in the SE and SW portions of the main block have also been re-activated, though at a much slower rate. No present activity was observed in the area of main block, on the smaller blocks above, or in the Pokladnice cave.

A limited degree of re-activation was also observed in the Kopce slope failure. The central block part and the tension-zone pressure ridges revealed no surface indications of recent movements (Fig. 17C). Only a small shallow slide, about 10–15 m long, was triggered in the accumulation zone in 1997. Later, a debris flow was activated in 1999 after snow melting and intensive deforestation in its source area. Following its movement, the formation of distinct cracks around the emptied source area (the tension zone) revealed that the material is creeping and sliding down into the source area; thus, there is a clear tendency for the source area to be filled in again, preparing material for the next event.
